**D.U.L
LABORATORIES LTD**

**Indicative fire resistance
test utilising the test
methodology given in:
BS 476 Part 21 : 1987
BS EN 1363-1 : 2020**

Prepared for:
Hoody Speaker Hoods Ltd
2 Lakeview Stables, Lower St.
Clere, Kemsing, Sevenoaks
TN15 6NL

Test Report Number 20730

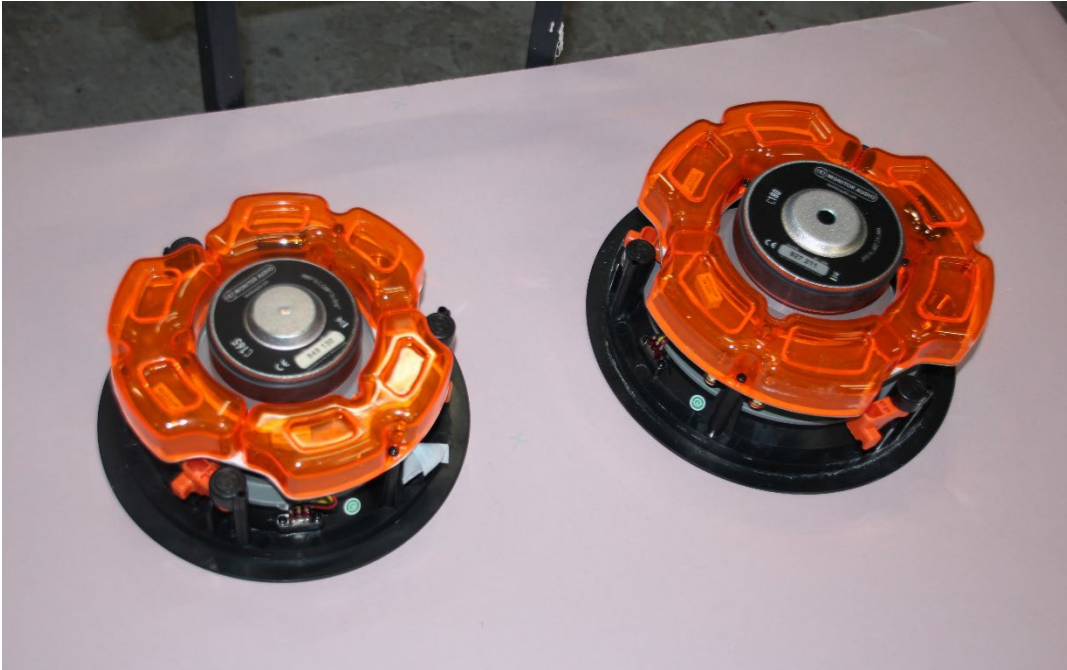
Photo 1 – Before test, Hoody Speakers No 1 and No 2 before installation

- Hoody Speaker No 1 – Monitor Audio C165
Overall diameter including grille – 250mm
Cut out size diameter – 211mm diameter
Mounting depth – 114mm
Weight – 1.92kg
The speaker fire cover fitted over Hoody Speaker no 2
- Hoody Speaker No 2 – Monitor Audio C180
Overall diameter including grille – 285mm
Cut out size diameter – 211mm
Mounting depth – 121mm
The speaker fire cover fitted over Hoody Speaker no 1

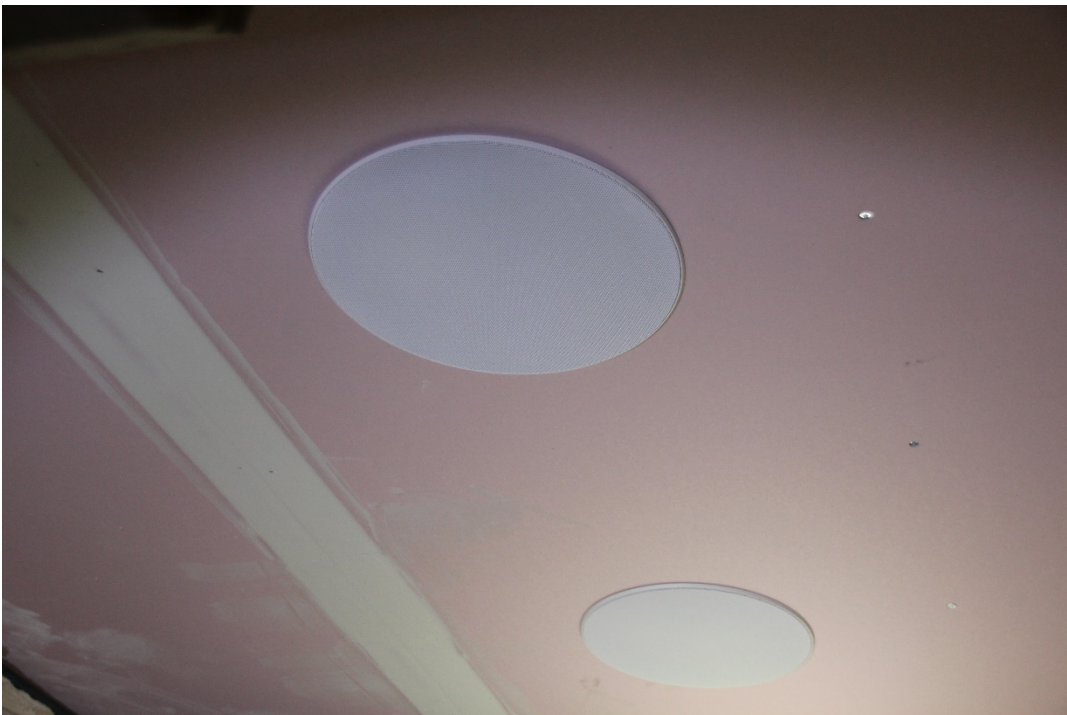
Photo 2 – Before test on exposed side showing the speakers installed into ceiling

The ceiling area was 1800mm x 1800mm. It was manufactured using six 50mm x 250mm softwood joists. On the exposed side, two layers of 12.5mm plasterboard were screwed to the underside of the joists. On the unexposed side, one layer of 18mm OSB board was screwed on top of the joists.

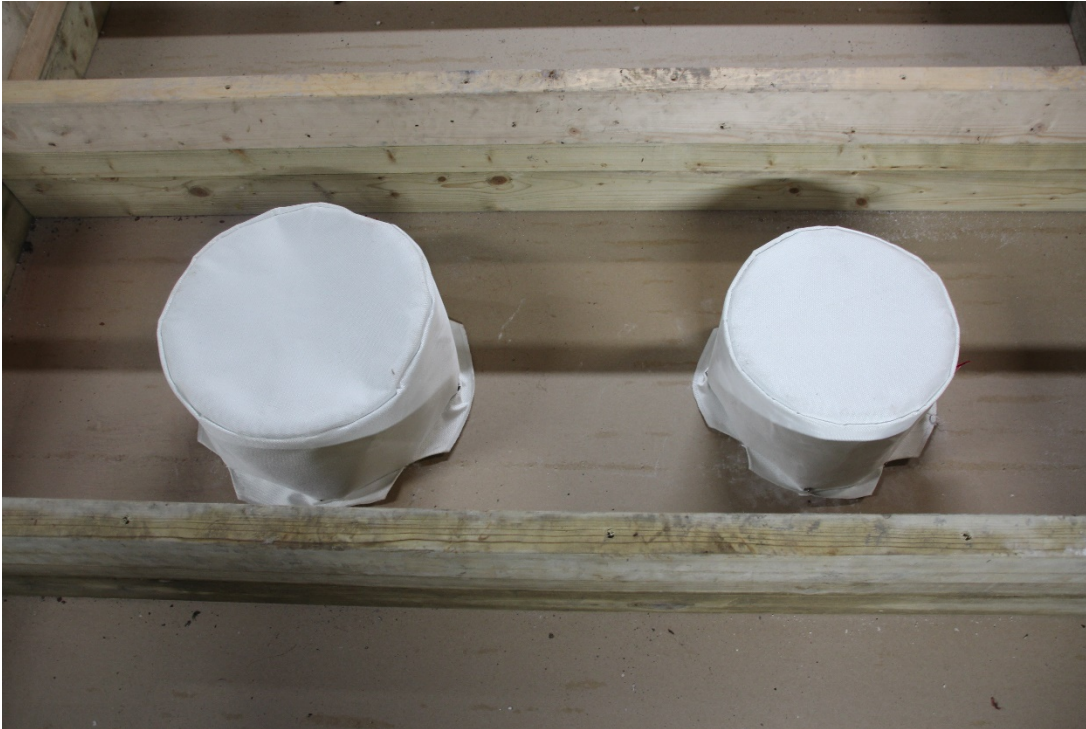
Photo 3 – Before test on unexposed side to show location of Hoody fireproof acoustic covers. This is before the 18mm OSB board was fitted over the top of the joists

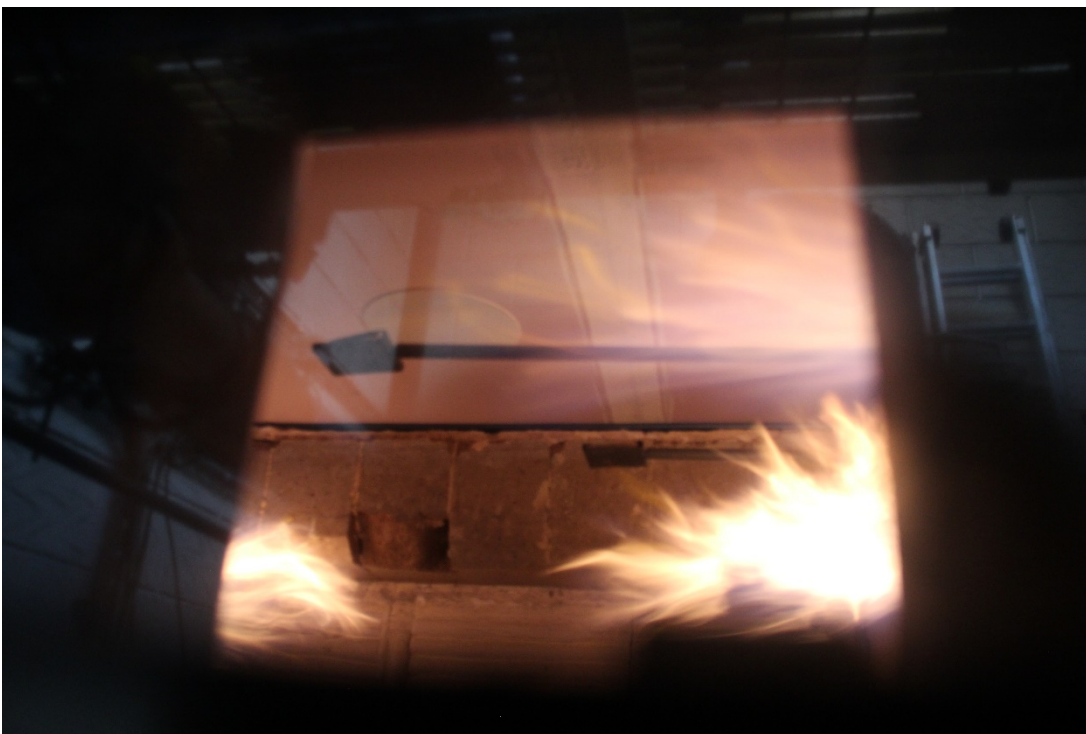
Photo 4 – Exposed side at start of test

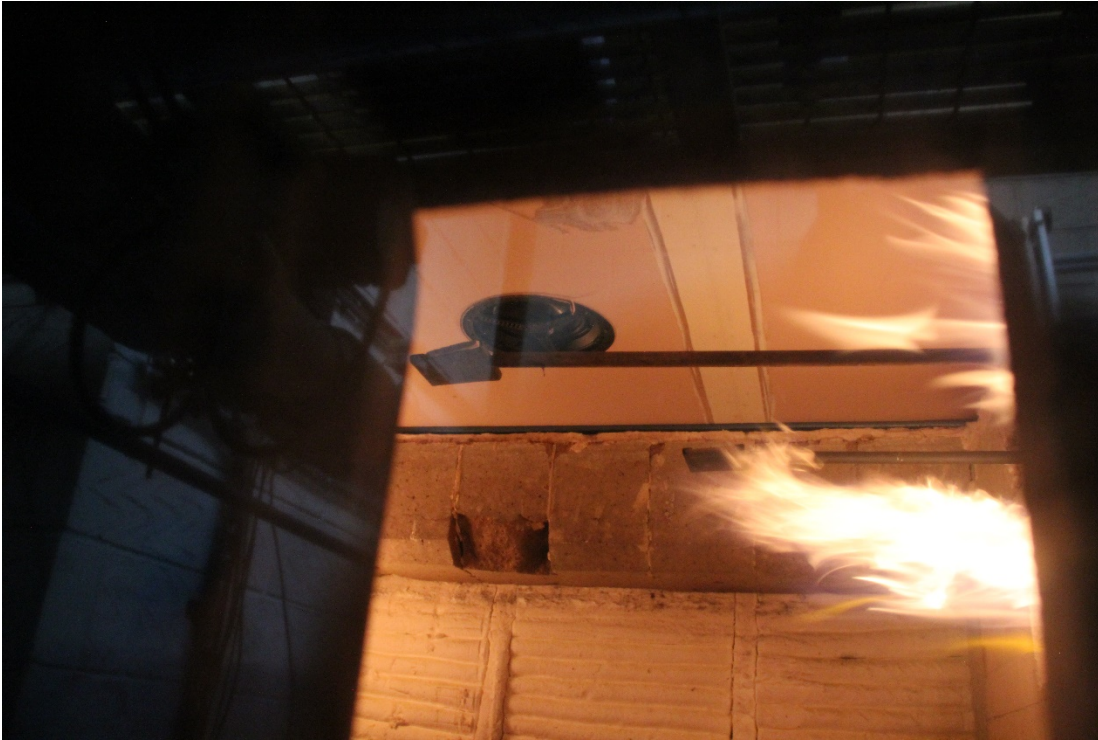
Photo 5 – 1 minute into test on exposed side where the magnetic speaker covers have fallen

Time	Observations
0 minutes	Start of test
1 minutes	The Hoody speakers magnetic cover fell off
2 minutes	The Hoody speakers dropped
5 minutes	Hoody fireproof acoustic covers remains intact
20 minutes	No significant changes
30 minutes	No significant changes
45 minutes	No significant changes
55 minutes	First layer of plasterboard starts to drop
60 minutes	Second layer of plasterboard is exposed
64 minutes	Fire penetrates through second layer of plasterboard. Test stopped.

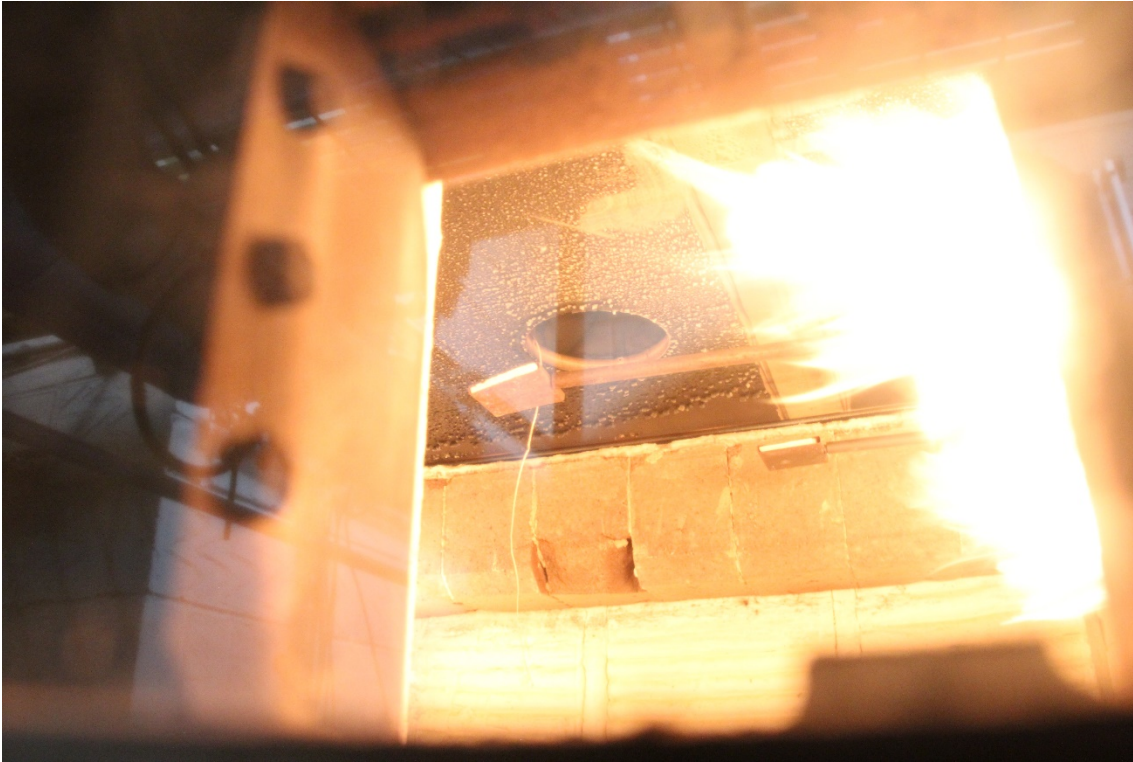
Photo 7 – 5 minutes into test on exposed side, the Hoody fireproof covers are still intact

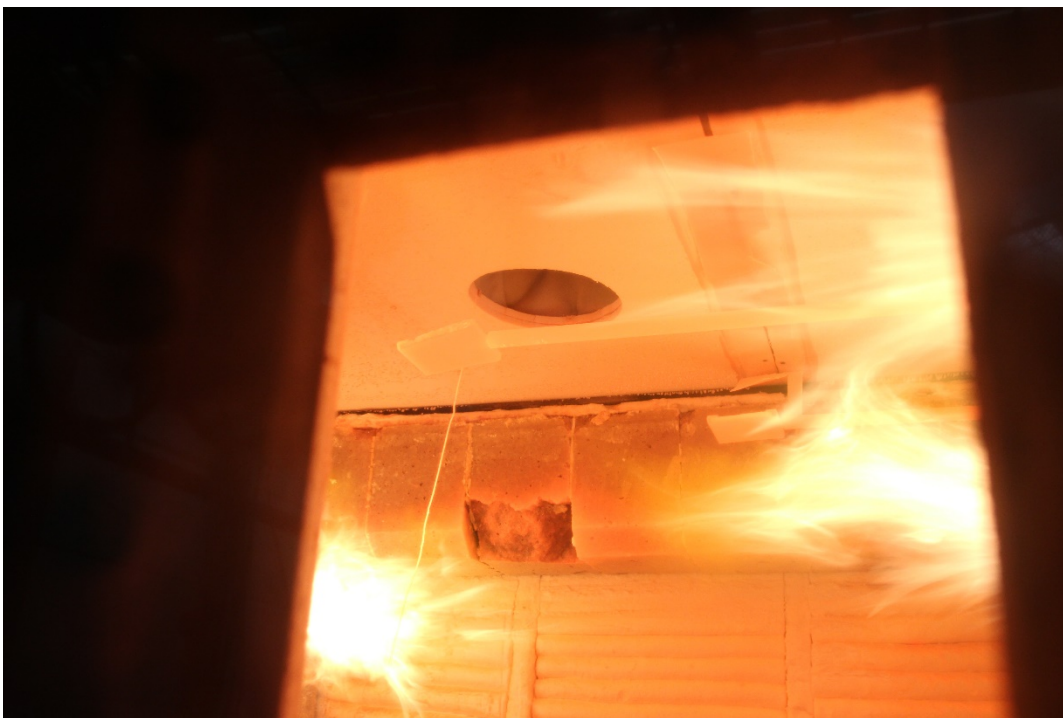
Photo 10 – 45 minutes into test on exposed side
